## Effects of Weather on Service Lives of External Building Finishing: A Case Study of Ilaro, Nigeria

A. A. Aiyegbaje

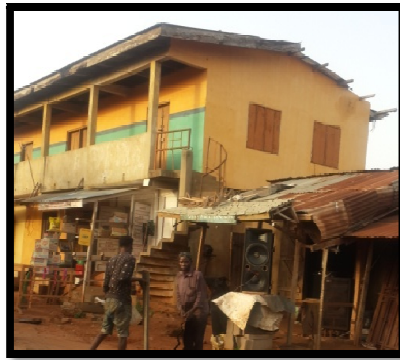
*Figure 3: Commercial Building at Orita Oja Odan Road Completed for Over 20 Years fairly affected by Weather  
Source: Authors Field Photograph 2017*

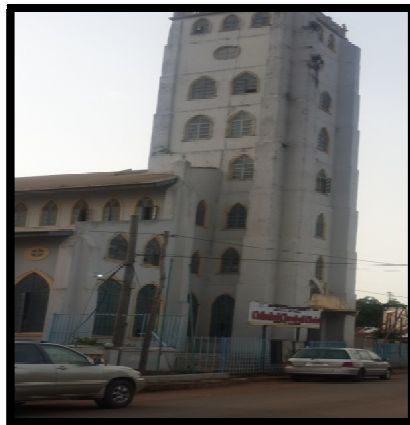
*Figure 4: Cathedral Church Ona Ola Road Completed for Over 50 Years Enjoys Regular Maintenance  
Source: Authors Field*

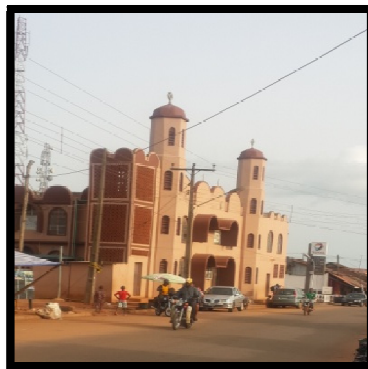
*Figure 5: Central Mosque Completed between 20-30years fairly affected by weather  
Source: Authors Field Photograph (2017)*

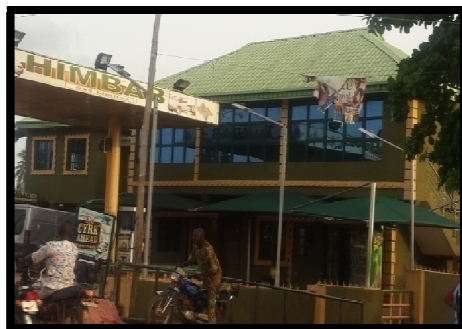
*Figure 8: Commercial Building with Glass/Painted/  
Wall Finish along Library Area Rehabilitated within  
The Last 10 Years*

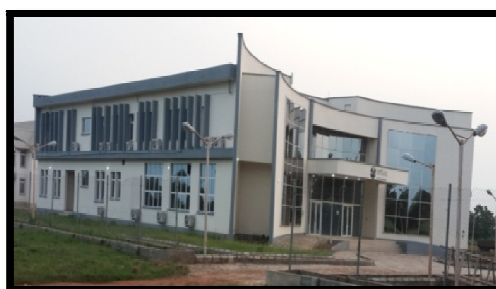
*Figure 9: International Conference Centre of Finished with Glass  
Painted Wall at Federal Polytechnic Ilaro, Completed within the Last 10  
Years Source: Authors Field Photograph 2017*

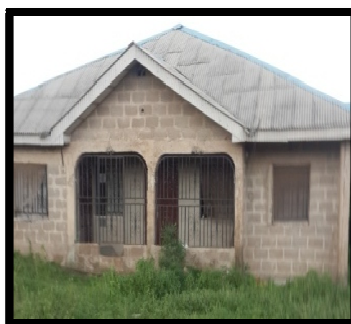
*Figure 10: Residential Building with Unplastered Block Wall  
in Use for Less Than 10 Years at Express Road*

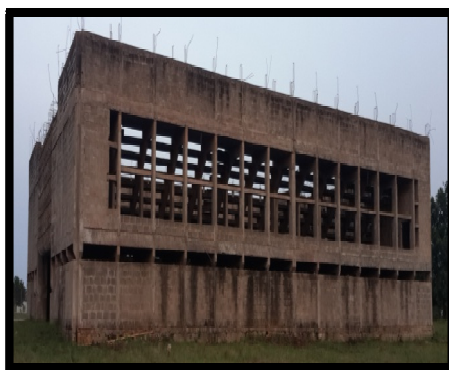
*Figure 11: Sport Centre Unplastered Block Wall Abandoned For Over 40 Years at Federal Polytechnic Ilaro. Badly Affected by Weather  
Source: Authors Field Photograph 2017*

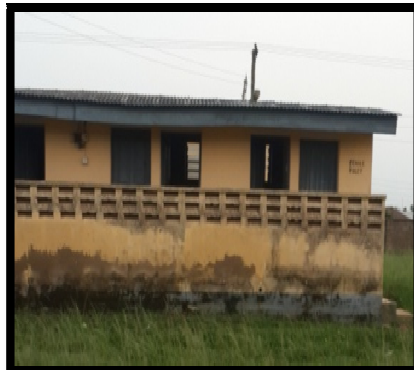
*Figure 12: Public Toilet at Federal Polytechnic Ilaro Completed in Less Than 10 Years, Badly Affected by Weather  
Source: Authors Field Photograph 2017*

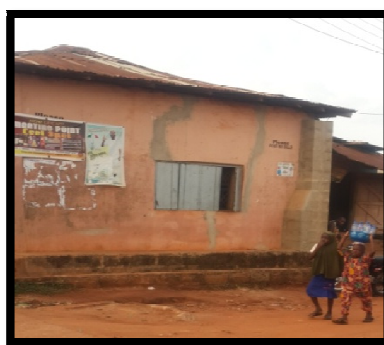
*Figure 13: Classroom Building at Library Area Completed in Less Than 10 Years, Badly Affected by Weather  
Source: Authors Field Photograph 2017*
