A Study of Fire Safety in Hostel Design: Case Study of Nnamdi Azikiwe University, Anambra State, Nigeria

Okwuagwu Marvelous Ifeanyi

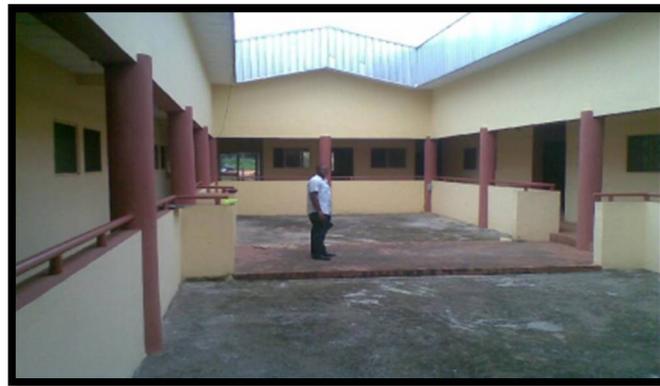
Figure 2: Showing the Court Yard and the Corridors
(Horizontal Means of Escape)
Source: Author

With the inclusion of the courtyard, cross ventilation was accomplished, and a simple exit was made available in the event that a fire broke out inside the hostel. Fire resistance was not a factor in the building's design. Fire-resistant doors and walls were not used in the hostel to prevent the spread of the fire and enable occupants to flee in case of fire. Equipment for first-aid firefighting, which could help the fire department when they arrive, is not provided. Examples include hydrant systems, fire hose reels, extinguishers, fire buckets, fire blankets, and so forth.

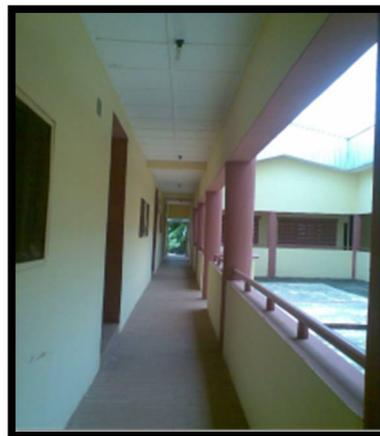
Figure 3: Show Escape Route
Source: Author's Fieldwork
