Assessment of Fire Risk for Mike Adenuga Library, Bells University, Ota, Nigeria

This study carries out an assessment of the fire risk of the Mike Adenuga building, Bells University of Technology, with an aim to provide first-hand information on the building, its fire prevention, and safety measures. It serves to raise awareness of the possible causes of fire, the consequences of fire events, and mitigation strategies in the facility with the aim of protecting users' lives, businesses, properties, and the university's equipment against fires.

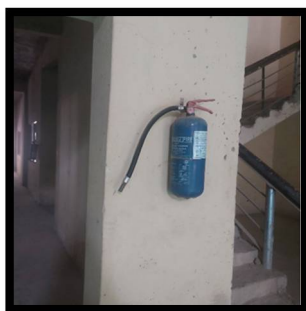
Figure 4: Image Showing Fire Extinguisher Close to the Fire Escape Staircase
Source: Author's Fieldwork, 2022

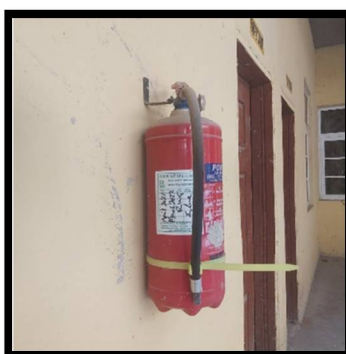
Figure 5: Images Showing Fire Extinguishers Positioned in Front of the Laboratories in the Courtyard Space of the Building
Source: Author's Fieldwork, 2022

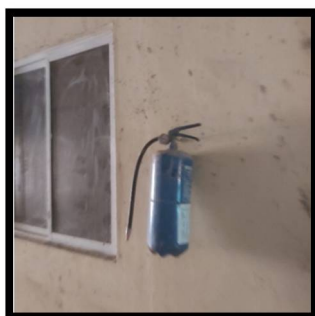
Figure 6: Images Showing Fire Extinguishers Positioned in Front of the Laboratories in the Courtyard Space of the Building
Source: Author's Fieldwork, 2022

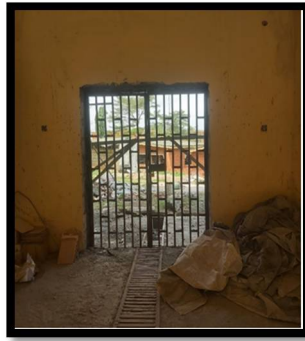
Figure 7: Images Showing Blocked Exit Points in the Building
Source: Author's Fieldwork, 2022

- The gates for the escape stairs leading out of the building should be unlocked as they are not currently serving their intended purpose by being locked.

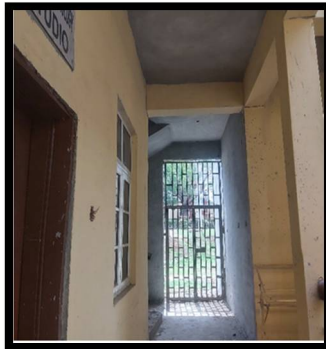
Figure 8: Images Showing an Exit Point Leading from Escape Staircase in the Building
Source: Author's Fieldwork, 2022

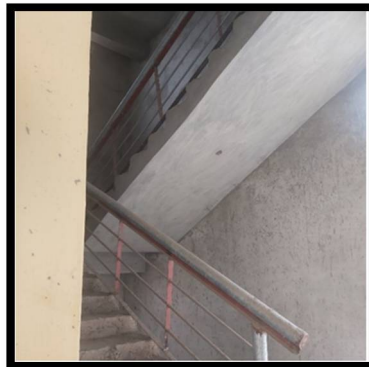
Figure 9: Images Showing the Escape Staircase in the Building.
Source: Author's Fieldwork, 2022

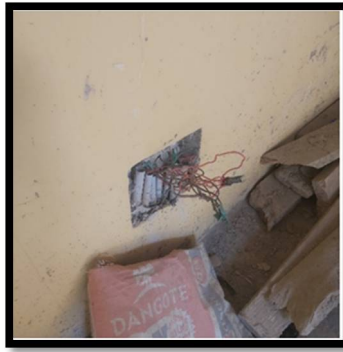
The main cause of the fire to the building might be the electrical failures or deliberate efforts known as arson. This is because there is no direct fire source in the building, like open flames from a kitchen or workshop, but there are a lot of exposed electrical fittings throughout the building.

*Figure 10: Image Showing One of the Many Exposed Sockets in the Building
Source: Author's Fieldwork, 2022*

- Electrical fittings and wires left exposed should be repaired to prevent the action of animals, humans, and weather from resulting in a fire outbreak.

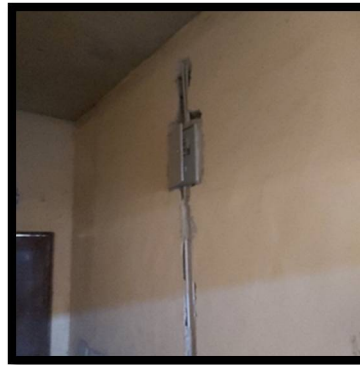
*Figure 11: Image Showing an Electrical Distribution Board with Some Exposed Wiring
Source: Author's Fieldwork, 2022*
