## Assessment of the Liquid Waste Management Practice of Condominium Houses in Addis Ababa, Ethiopia

*Objective; To determine the Effluent Management system and Practice of selected Condominium Houses in Addis Ababa*

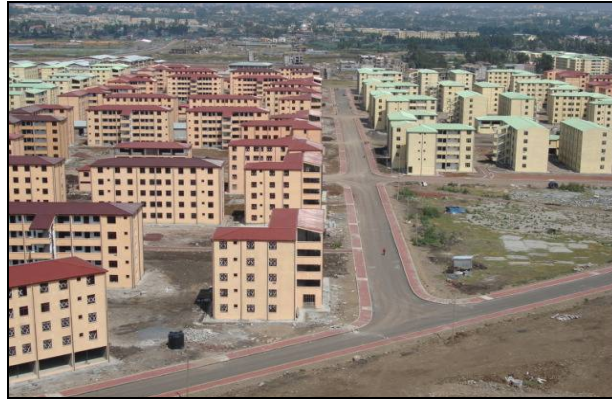
Figure 1: condominium site 2014 G C

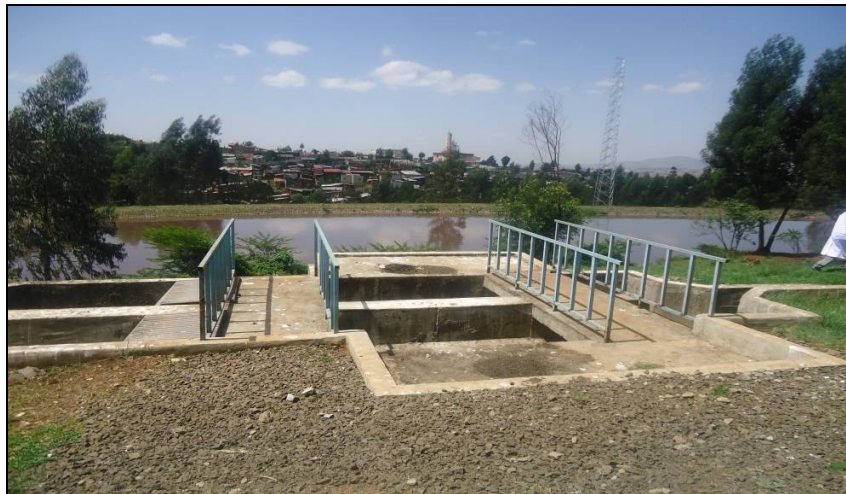
The some effluent sludge produced after treatment was collected and transported to treatment facility by 48 vehicles but which need additional truck mounted vacuum tanks and small. But in this case it is difficult. Because this needs several trips to collect the effluent sludge by vehicles but the vehicles engaged in such activity in Addis Ababa city are approximately 63, out of these only 48 are functional. They also burn it and use as fertile. On-site sanitation systems of septic systems require periodic removal of solids for proper functioning. Collection is accomplished by manual means with mechanical equipment.

Figure 2: waste water treatment plant 2014 G C
