## **A Report On The Threat Of *Leucaena Leucocephala* Lam Dewit. On infrastructure: A Case Study Of Adeyemi College Of Education, Ondo, Nigeria**

**Adenegan- Alakinde, T.A, BADERINWA-ADEJUMO, A.O  
And SANNI, R.O**  
Department Of Biology  
Adeyemi college of education, Ondo, Nigeria

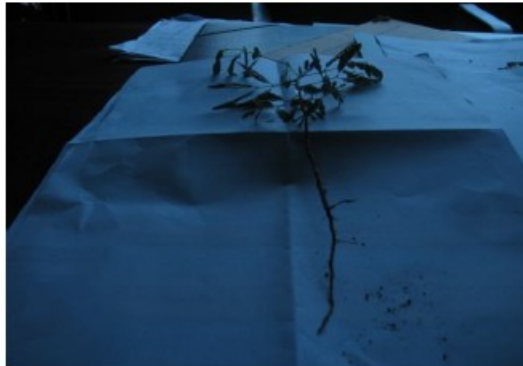
Figure 2: Seedling of *L. leucocephala* showing the slender tap root.

small and brown, (Figure 1) making them to be easily carried by dispersal agents. The brown colour of the seeds make it difficult to be seen by predators. The thin slender tap root system of the seedlings enable seeds to germinate and develop in the smallest openings (Figure 2) As a result of this, *L. leucocephala* are found growing in odd places; cracks, on the rocks, crevices in soak away, building foundations e.t.c. If the present rate of its invasion in not checked, within the next few years *L. leucocephala* would have taken over the entire campus.

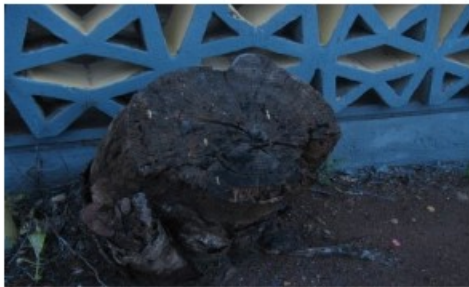
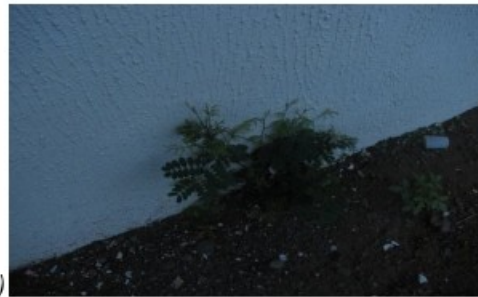
Secondly, the presence of *L. leucocephala* in undesired places destroys the aesthetic value of such places. Figure 3a showed the presence of *L. leucocephala* on the foundation of a building. This tree was very close to a verandah, but was unchecked. There is no reason why the tree was not removed earlier since in the locality where the study area is located, this plant do not have any ethno-botanical uses except the provision of shade in some cases where *Ficus* spp. and *Terminalia* spp. are not available. The presence of *L. leucocephala* close to the wall is not required because there is no need of shade. Figure 3b also showed *L. leucocephala* on a foundation. The presence of this plant in unwanted places removes the beauty of that area, makes it unwholesome. The presence of these plants on foundation weakens the foundation.

Figure 3 a and b: *L. leucocephala* having its root into the foundation of a building. Figure 3a is the Stump of *L. leucocephala* deep into the foundation.

The position of this paper is that these plants must be checked before they exert deleterious effects on structures. We must create awareness of the destructive tendency of *L. leucocephala* on structures and the need to checkmate their invasion despite some of their functional uses in agro system.

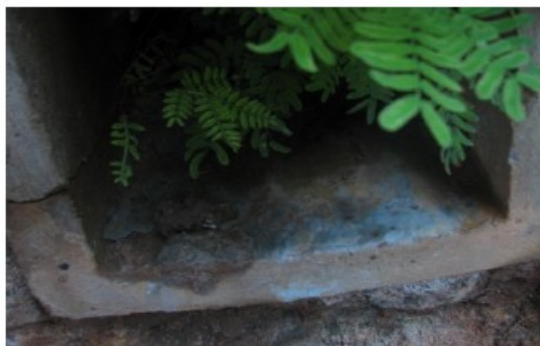
Figure 4 showed *L. leucocephala* growing at the opening of a drainage system. Presently it is not checked. Its presence is gradually blocking the flow of water and if care is not taking flow of water runoff may eventually be blocked. The penetrating roots have caused cracks on the concrete of the drainage. The presence of *L. leucocephala* at the opening of the drainage is disgusting.

Figure 4: *L. leucocephala* blocking one of the drainages

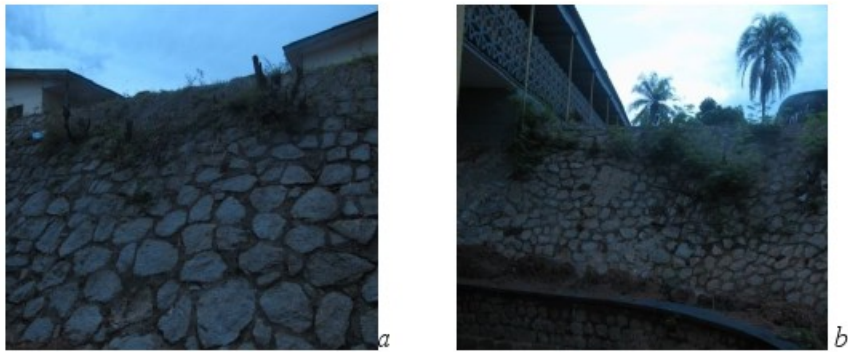
Figures 5a and b showed *L. leucocephala* growing on a beautiful well laid out stony embankment. The stony embankment added colour to that environment. Unfortunately the presence of this invasive plant is gradually over shadowing the beauty. More over the

concrete are weakened by the penetrating down the concrete. Within the next few years the embankment may bow down to physical forces and crumbles.

Figure 5 a and b showing *L. leucocephala* growing on a stony pavement.

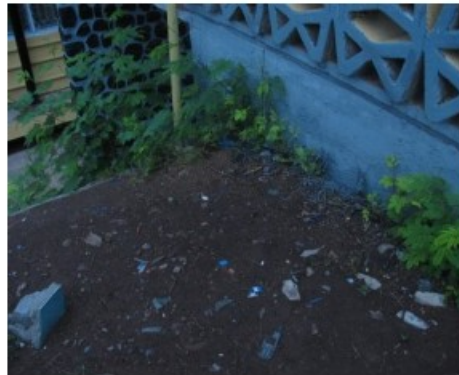
Figure 6 showed the seedlings of *L. leucocephala* growing a building and this makes the surrounding area unkempt. Despite the paintings on the walls the presence of these seedlings makes the place to be untidy.

Figure 6: Seedlings of *L. leucocephala* growing around a building.

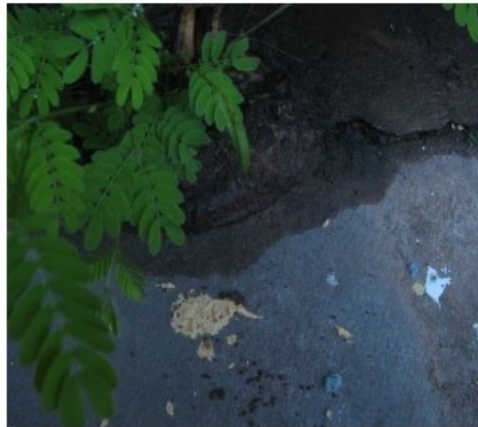
Figure 7 showed a matured plant attached to a concrete floor. This has been cut with matchet several times but it keeps rejuvenating. The black woody stump is not appealing to sight. It disfigures the entire area and cause cracks on the wall as the roots penetrate more and more underground.

Figure7: A matured *L. leucocephala* firmly attached to a concrete floor.

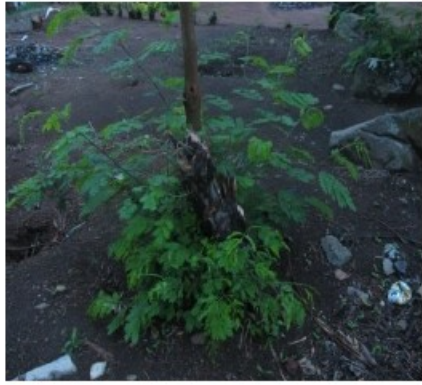
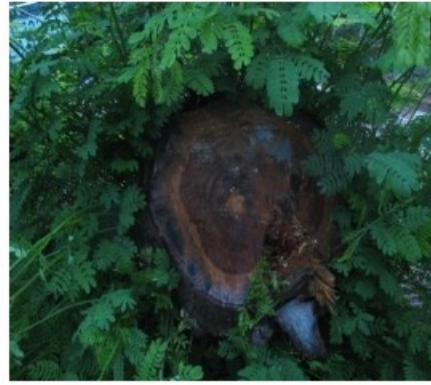
Nearly all *L. leucocephala* will coppice if cut once, but repeated cutting during the growing season would cause depletion of root reserves which eventually result in death. *L. leucocephala* has the ability to grow again despite several matchet cuts and uprooting. This has made elimination difficult. Figure 8a and b showed thickets of regrowth after the plant has been cut. In Figure 8a *L. leucocephala* has been cut more than twice but it keeps rejuvenating.

*Figure 8: L. leucocephala that had been cut showing dense thickets of regrowth.*

Whichever method or combination of methods chosen there are general principles to follow. Firstly, light infestations are easier to deal with than heavy infestation. They can also get worse if ignored. Heavy infestation may not be easy to deal with. It is better to tackle the easiest problem. Secondly, no control operation succeeds for the first time. One or more follow ups are essential. When attempting to clear a large area, it is should done, clearing a portion at a time, gradually increasing the area covered. There is the need to always check back on the areas cleared earlier to ensure that there is no reinfestation.
