Failure Analysis Of Rear Axle Of A Tractor With Loaded Trolley

Abstract:

This paper describes the failure analysis of the rear axle at the root of the spline of a tractor with a loaded trolley used for haulage operation. The analysis has been made using the principles of mechanics. The reason behind the failure has been found to be the weight transfer from front to rear, reduction of which is considered to be a remedial measure for the occurrence failure.

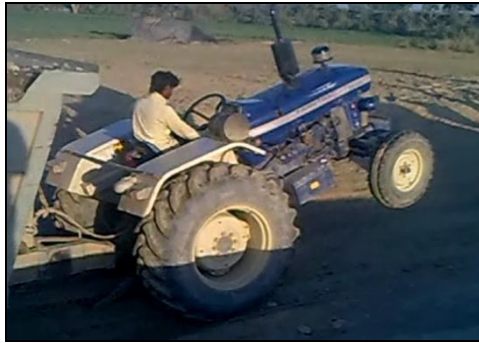
Figure 1

During the forward movement of a rear wheel drive tractor with a drawbar pull, a weight transfer from the front wheel to the rear wheel ensues. As a result of this the front wheels develop poor ground contact as compared to the rear wheels and the tractor tends to get lifted up from the front (Figure – 1). When the front wheel gets lifted up the steering does not respond to the operator. Such an occurrence is risky and prone to accidents. As a consequence of the lifting of the front wheel the entire weight of the tractor along with the torsional driving load acts on the rear axle. Due to repeated application of the above loads on the rear axle, the axle fails within a span of 600 to 1000 hours of operation because of fatigue (Figure-2). The pattern of the splines of the failed shafts at the root of the spline indicates the effect of the torsional load.
