Review Paper on the Failure Analysis of Weld: Neck Flanges

Abstract:

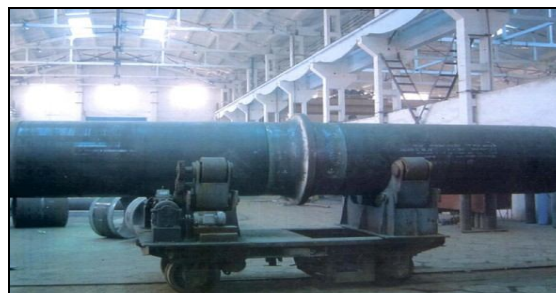
Figure shows a typical Welded Neck Flange

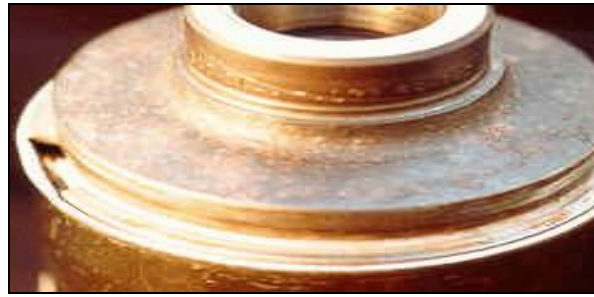
A ruptured welded neck flange
