Intelligent Pigging of 48” diameter, 20 KM Offshore Crude Oil Pipeline at BPCL, Kochi, India

KEI-RSOS Maritime Limited (KRML) was entrusted by Bharat Petroleum Corporation Limited (BPCL), India to carry out the Intelligent Pigging of 48” diameter, 20 KM Crude oil offshore pipeline from STF to SPM at Kochi SPM facility. KRML in association with M/s. 3P Services, Germany, executed the pigging project successfully. The methodology used for this project was Bi-directional pigging, which is the latest & was carried out first time in India. The paper discusses the details of the project including utilisation of cleaning pig, GEO pig, Intelligent (MFL) pig and our experiences. The paper also discusses the advantages & the benefits of the technology related to reduction in project execution time & project cost, simplicity of operation and environmental friendliness. The limitation of the method & problem encountered are also discussed and shared, so that the offshore industry can take benefit from our experience, in future.

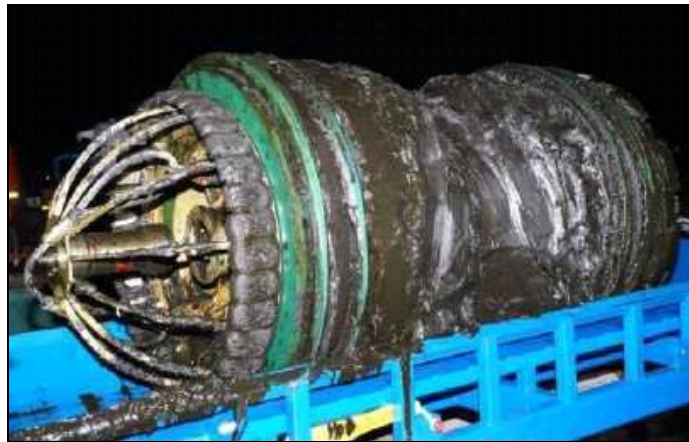
Figure 1

The paraffin load had an estimated weight of 600kg. It was primarily sitting between the discs with only minor volumes in front and behind the tool.

On the trip back to shore a major volume of paraffin in front of the tool may have escaped with the general flow into the tank farm prior to the arrival of the tool on shore. Further paraffin is expected to have entered the trap together with the tool. It is assumed that the vacuum truck that emptied the trap prior to opening may have taken out most of this paraffin.

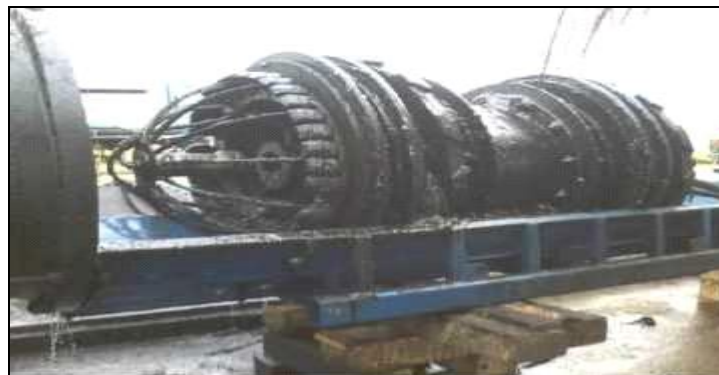
Figure 2

After the tool had been received in the trap there was a delay of approx. 14h. Since it was a hot day with permanent direct sunlight onto the trap the entire installation heated up significantly. Therefore, the collected paraffin had a chance to melt down from its original position on the tool and it was found all around the bottom of the tool in the tray when finally pulled out of the trap. The estimate of paraffin collected was approx. 400 kg. The overall condition of the pipeline in view towards pipeline inspection was interpreted to have not improved from run #1 to run #2 and, consequently, it was declared “not ok” for continuation. The first phase of the pigging campaign was concluded and 3P Services’ personnel demobilized.

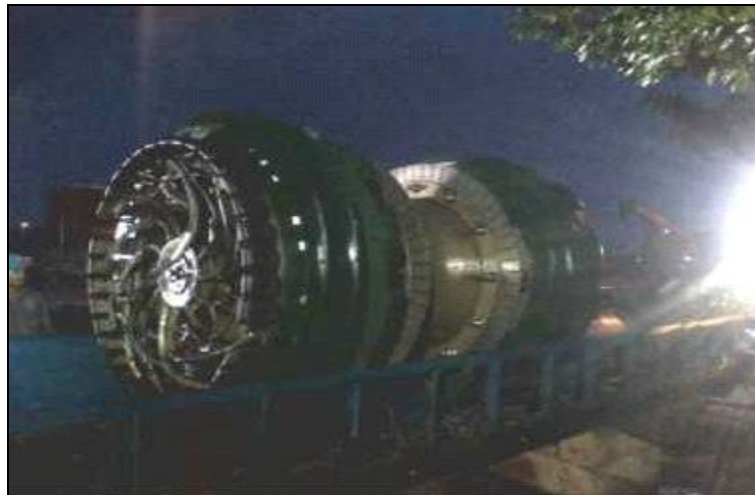
Figure 3

Cleaning/profile tool with gauge plates and transmitter after run No solid paraffin was found on or around the tool.

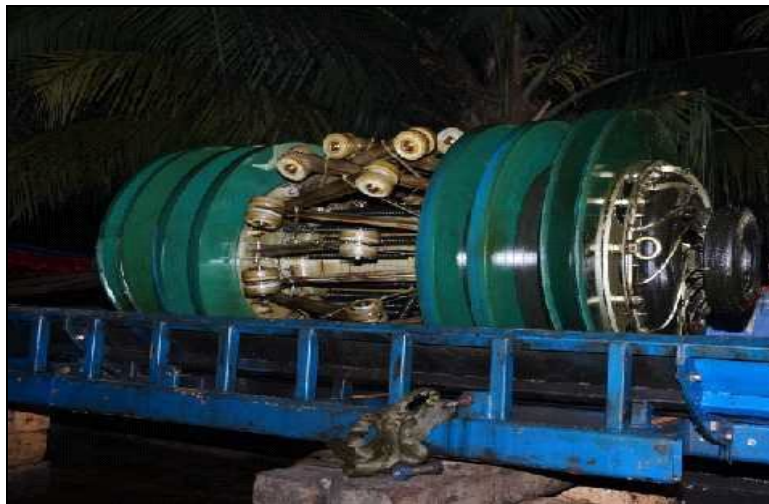
Figure 5

The GEO tool has operated well in all components. The tool vibration is clearly recorded by the 48 GEO arms. The measurement capability is generally not influenced by the vibration.

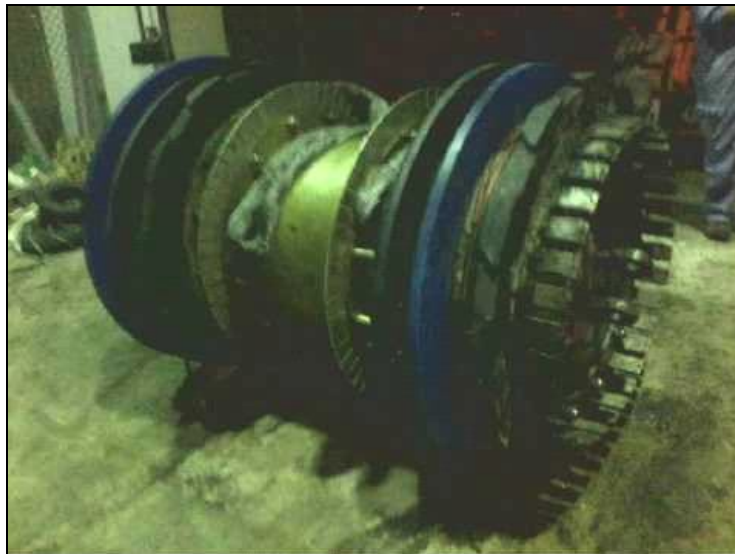
Figure 6

Cleaning/profile tool with gauge plates after run

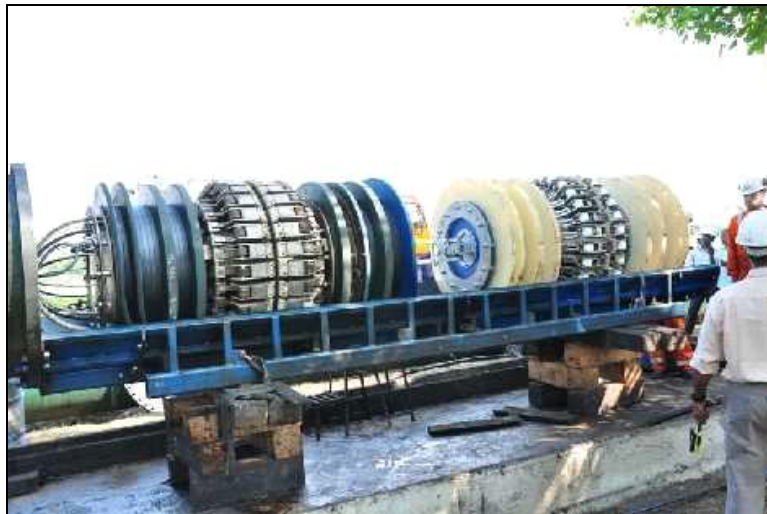
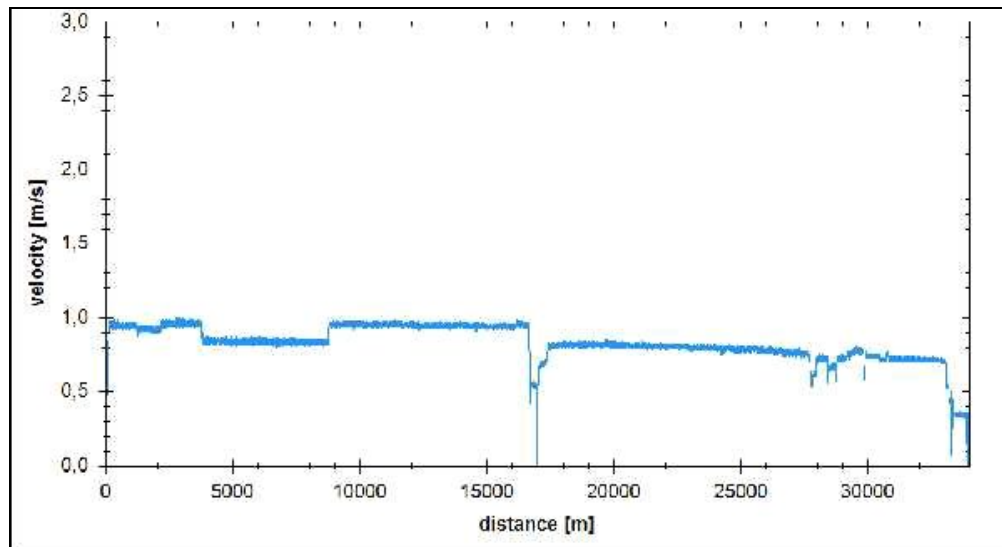
In order to reduce the risk of vibrations as occurred on the GEO tool, a significantly slower travelling speed was suggested for the MFL run. Due to limited flexibility of the crude pump spread at STF the speed was set at 0.9 m/s. Why the speed profile shows reduced speed between approx. 4000m and 8500m is not known. On the way back to shore the speed was generally between 0.7 and 0.8m/s. Data records from both way out and way back are good. On the way out towards the PLEM occasional vibrations were recorded, however, significantly less than the GEO.
