A Suitable Landscape Design for Areas Affected by Gully Erosion in Jos, Plateau State, Nigeria

Emmamoge Orewere

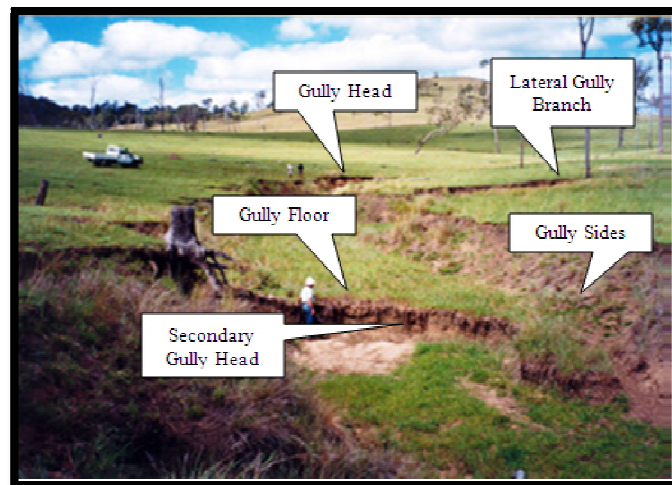
2.2.1. Components of a Gully

Figure 1: The Components of a Gully
 Source: Adapted from Soil Conservation Guidelines for Queensland, 2015

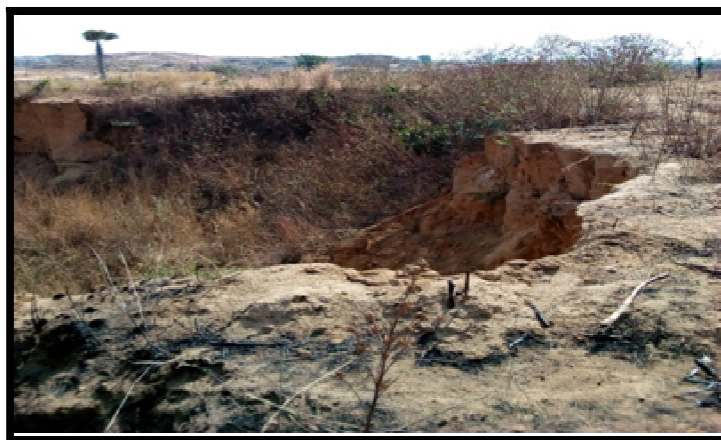
Runoff gains energy as it flows over a gully head into a plunge pool, causing various gully expansion processes to occur. A gully, like a stream out of balance, attempts to reach a new balance as it goes through processes that may change its length, depth and width. (Soil conservation guidelines for Queensland, 2015). Mining activities can create steep spoil heaps with exposed dispersive subsoil. Such sites are also prone to serious gully erosion.

Figure 2: Expansion of a Gully at Site
 Source: Researchers' Field Work, 2018

The following processes causes expansion of gullies these are raindrop impact, tunneling in dispersive soil, spalling, slaking , trickle flows, gully head advancement, basal sappingetc.

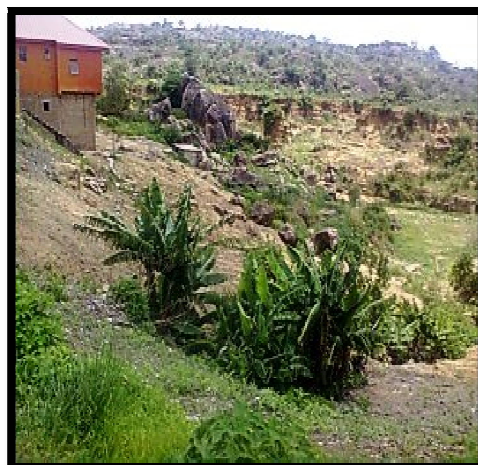
The topography of the site is a complex form that was forged gradually by erosion on the area which has been battered by mining activities, so a sketch was made of the contour on the survey map from data (elevation) take by the use of a hand held Geographical Positioning System device (GPS). The altitude of major land forms were taken and supplemented with computer generated coordinates and altitude from satellite imagery (Google earth 2016) for a wider coverage and precise space analysis in the course of the design process. Figure 7 and v shows the rock formation on and off site depicting the topography of the area

Figure 7: Topographic View from Off-Site
Source: Researchers' Field Work, 2018

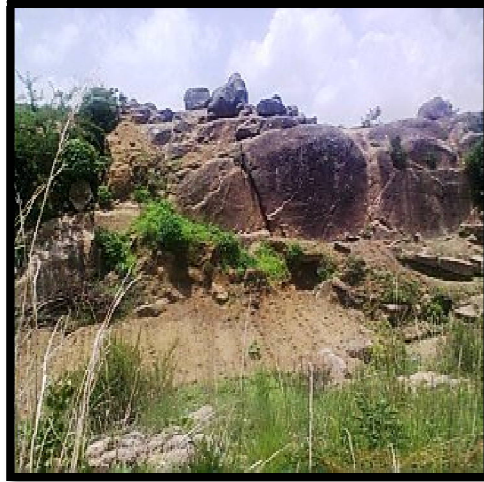
*Figure 8: Topographic View from on Site
Source: Researchers' Field Work, 2018*

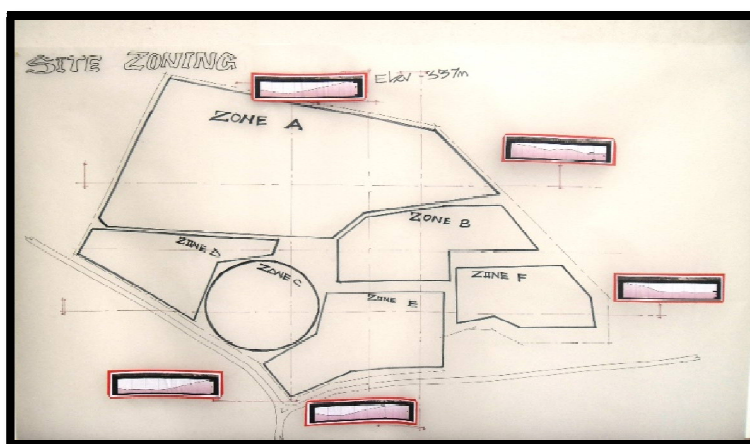
The site was zoned into seven parts bases on the topography of the site, this zone has introduced simplicity as seen in Figure 5.

Figure 18: Site Topographic Zoning Concept
Source: Researchers' Design Drawing, 2018

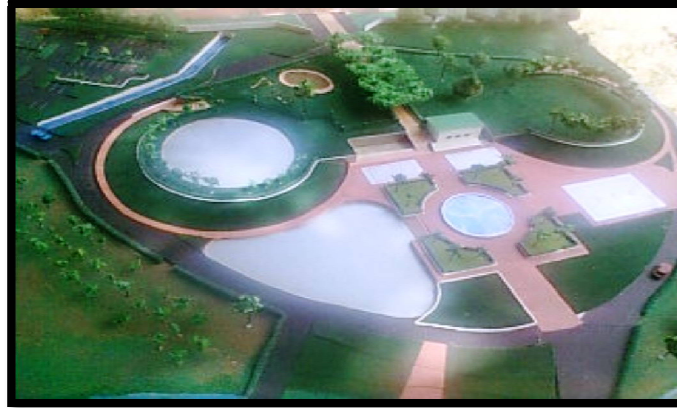
Figure 27: Landscaped Model with Proposed Facilities
Source: Researchers' 3D Model, 2018
