Pavement Deterioration And Its Causes

Sharad S.Adlinge

Abstract:

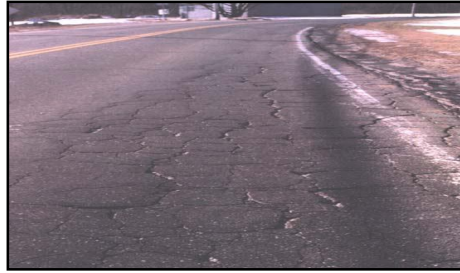
Figure 3: High severity alligator cracking

Fatigue cracking is commonly called alligator cracking. This is a series of interconnected cracks creating small, irregular shaped pieces of pavement. It is caused by failure of the surface layer or base due to repeated traffic loading (fatigue). Eventually the cracks lead to disintegration of the surface, as shown in Figure. The final result is potholes. Alligator cracking is usually associated with base or drainage problems. Small areas may be fixed with a patch or area repair. Larger areas require reclamation or reconstruction. Drainage must be carefully examined in all cases.

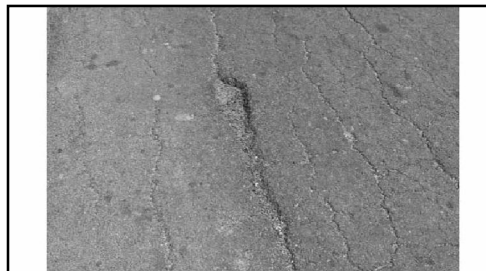
Figure 4: Longitudinal Cracking

Longitudinal cracks are long cracks that run parallel to the center line of the roadway. These may be caused by frost heaving or joint failures, or they may be load induced. Understanding the cause is critical to selecting the proper repair. Multiple parallel cracks may eventually form from the initial crack. This phenomenon, known as deterioration, is usually a sign that crack repairs are not the proper solution.

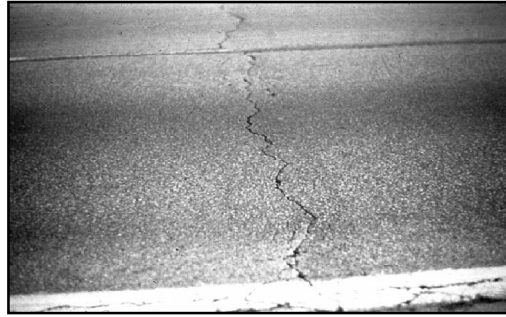
Figure 5: Low severity transverse crack

Transverse cracks form at approximately right angles to the centerline of the roadway. They are regularly spaced and have some of the same causes as longitudinal cracks. Transverse cracks will initially be widely spaced (over 20 feet apart). They usually begin as hairline or very narrow cracks and widen with age. If not properly sealed and maintained, secondary or multiple cracks develop, parallel to the initial crack. The reasons for transverse cracking, and the repairs, are similar to those for longitudinal cracking. In addition, thermal issues can lead to low-temperature cracking if the asphalt cement is too hard. Figure shows a low-severity transverse crack.

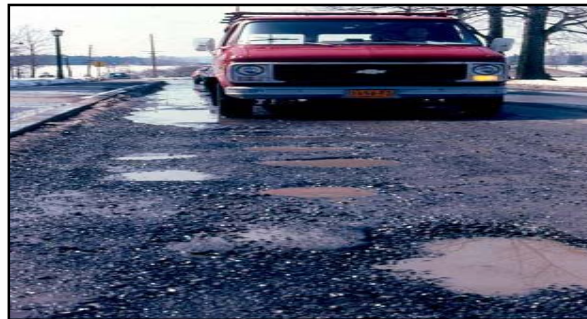
Figure 10: Potholes caused by poor drainage

Potholes are bowl-shaped holes similar to depressions. They are a progressive failure. First, small fragments of the top layer are dislodged. Over time, the distress will progress downward into the lower layers of the pavement. Potholes are often located in areas of poor drainage, as seen in Figure. Potholes are formed when the pavement disintegrates under traffic loading, due to inadequate strength in one or more layers of the pavement, usually accompanied by the presence of water. Most potholes would not occur if the root cause was repaired before development of the pothole. Repair by excavating and rebuilding. Area repairs or reconstruction may be required for extensive potholes.

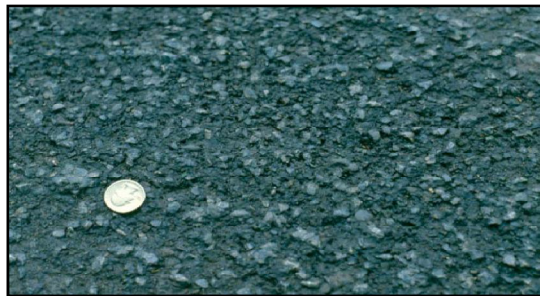
Figure 12: High severity ravelling of asphalt surface

Ravelling is the loss of material from the pavement surface. It is a result of insufficient adhesion between the asphalt cement and the aggregate. Initially, fine aggregate breaks loose and leaves small, rough patches in the surface of the pavement. As the disintegration continues, larger aggregate breaks loose, leaving rougher surfaces. Ravelling can be accelerated by traffic and freezing weather. Some ravelling in chip seals is due to improper construction technique. This can also lead to bleeding. Repair the problem with a wearing course or an overlay.
